REPORT ON THE XPS ANALYSIS OF A TITANMED DENTAL IMPLANT

Reference: D.d.t. TITANMED srl

XPS ANALYSIS ON DENTAL IMPLANTS

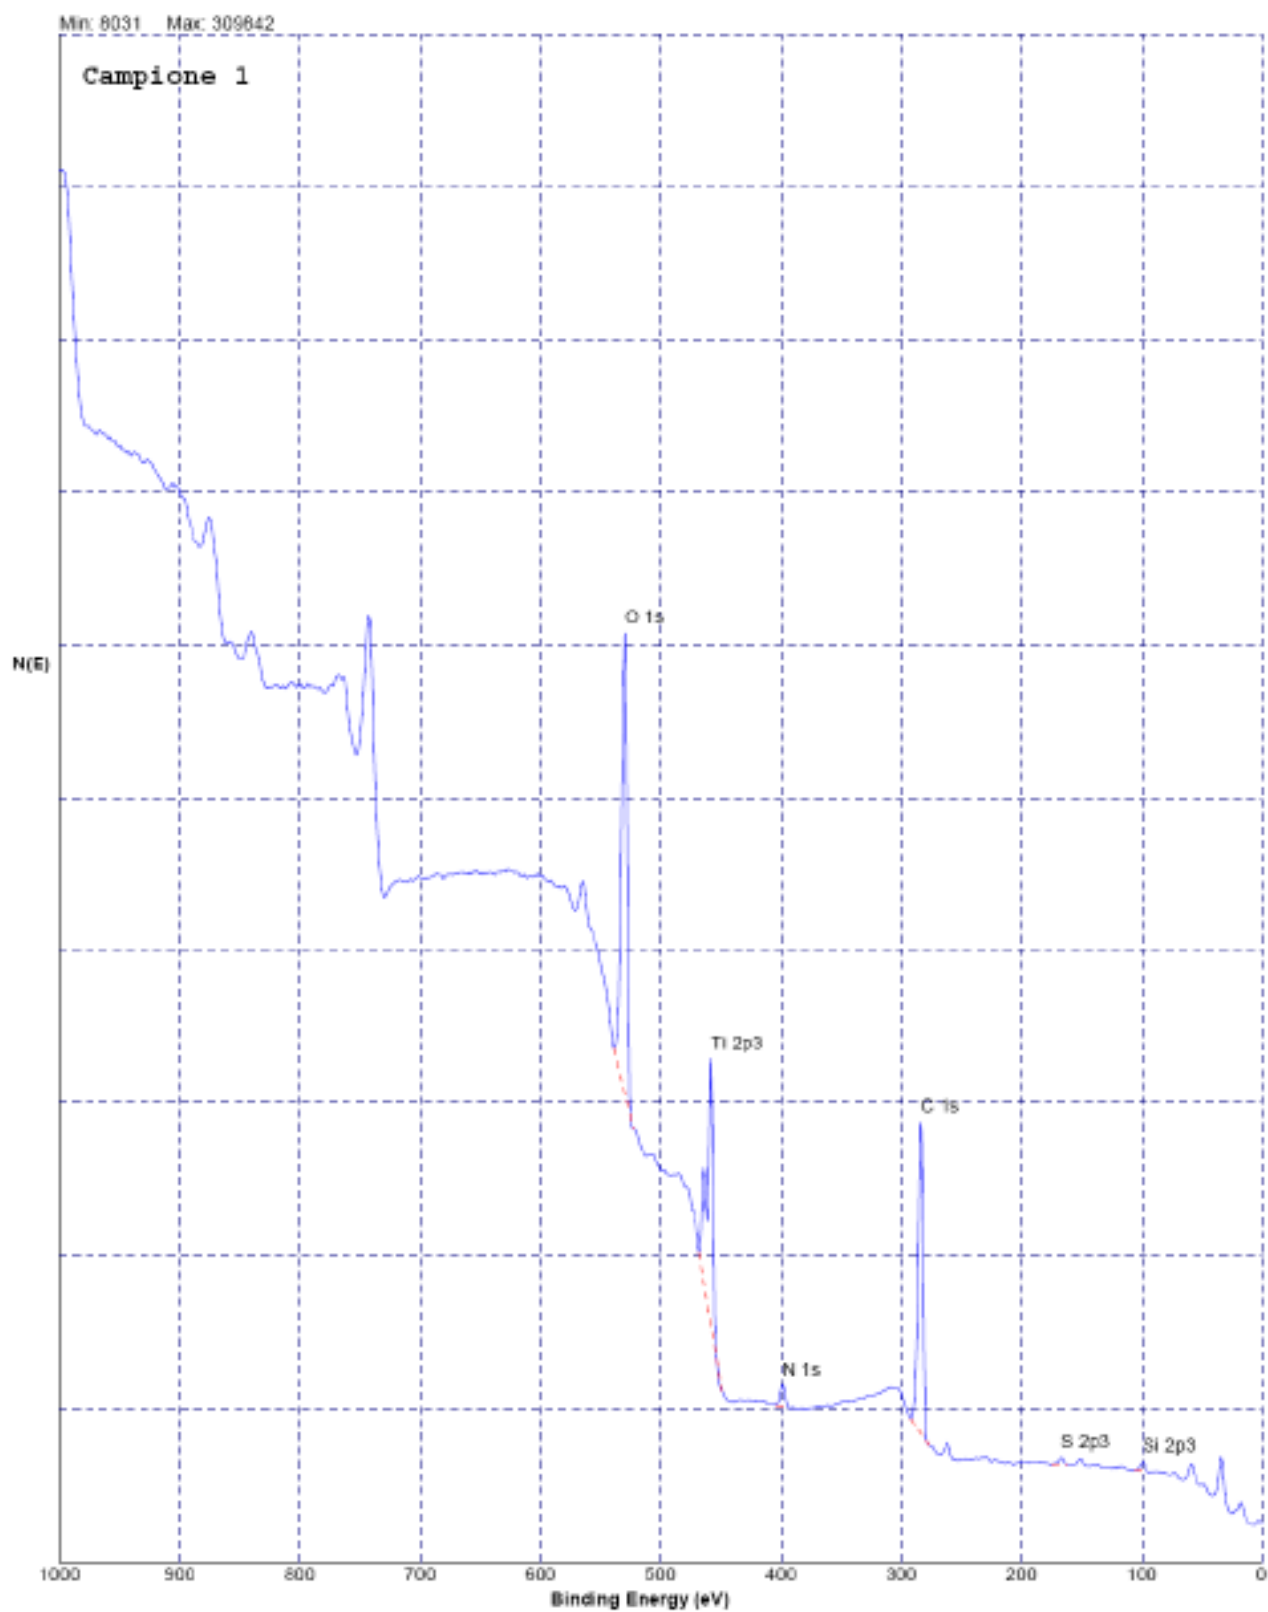
XPS Survey
EV/Step: 1 eV, Time/Step: 30 mSec, Sweeps: 50
Source: Mg, Pass Energy: 178.95 eV, Work Function: 0 eV

The XPS analysis of the implants has given the following results, the spectra are recorded on the following page:

Sample	O	Ti	N	Ca	C	Si	S	Na
1	37.4	13.9	0.7	0.6	44.7	1.1	0.1	0.6
2	38.4	13.8	0.8	0.8	44.2	1.3		0.7

The obtained results show a good superficial cleaning degree for both the analyzed samples. In particular, the Ti signal is quite high and the absolute value of the concentration agrees with what expected for cleaned surfaces. The carbon value and consequently the C/Ti ratio are surely acceptable and do not show a significant organic contamination presence. As are sandblasted samples, it is important to notice the total absence of Al, thing that confirms that sandblast waste has been effectively removed. As per the remaining observed elements, as per quality and quantity they are surely adequate to law as far as what can be identified on the same usage destination materials in commerce.

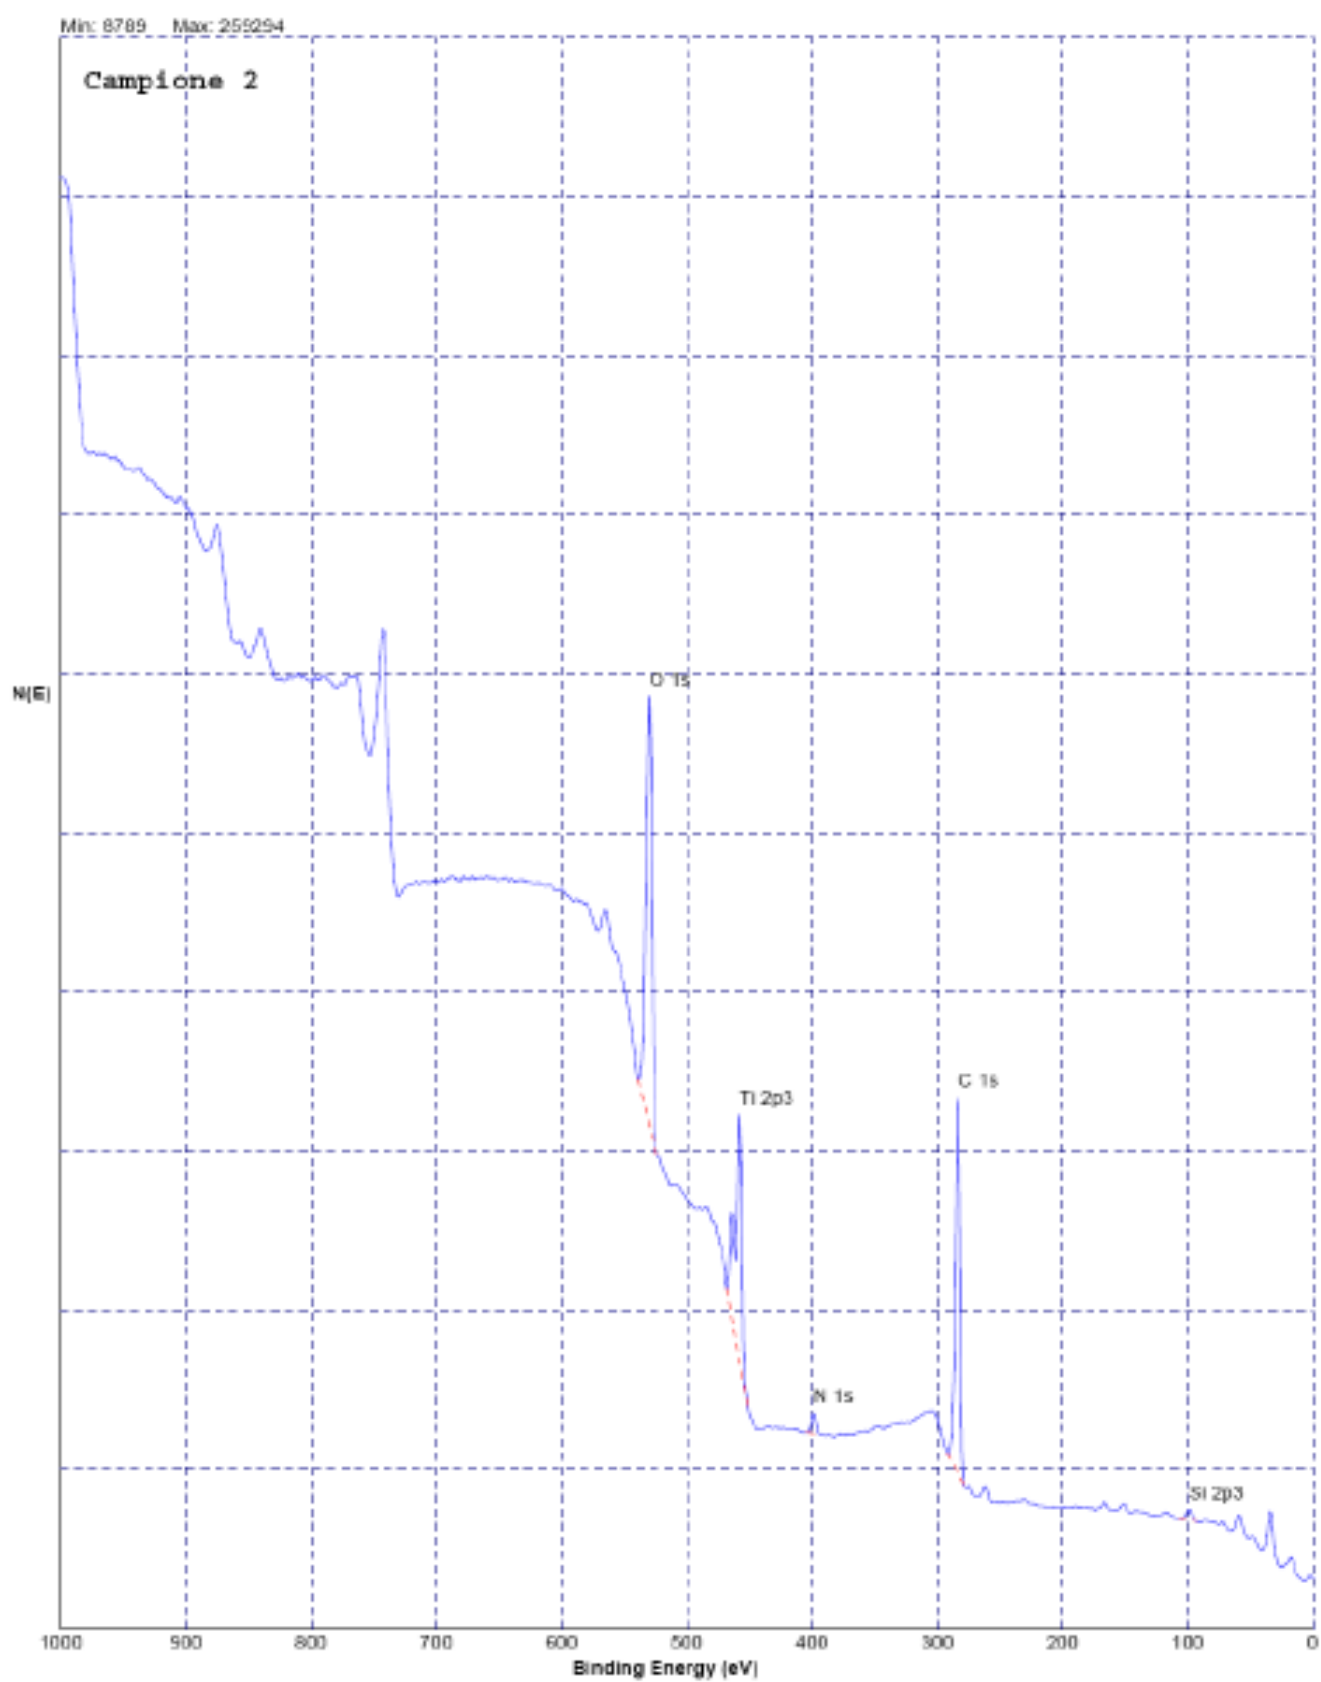
XPS Survey

EV/Step: 1 eV, Time/Step: 30 mSec, Sweeps: 50

Source: Mg, Pass Energy: 178.95 eV, Work Function: 0 eV
